U.S. Department
of Transportation
**Federal Aviation
Administration**

General Aviation Airworthiness Alerts

AC No. 43-16

**ALERT NO. 222
JANUARY 1997**

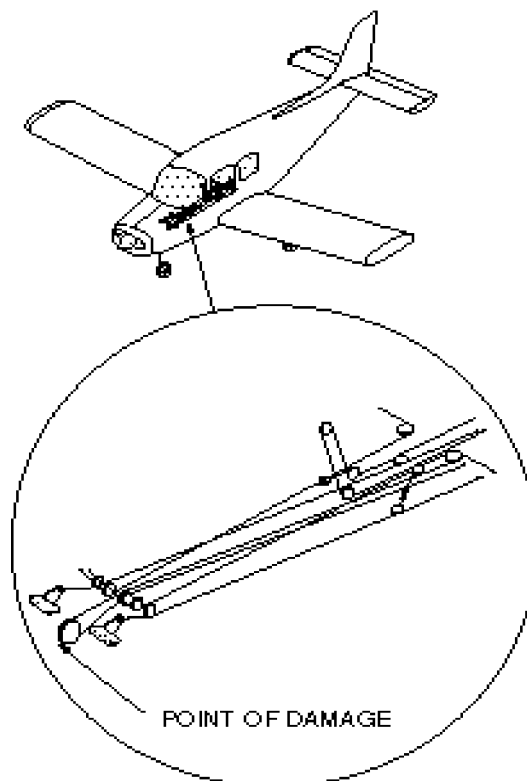
**Flight Control
Cable Damage
2730**

The stabilator control cable was found with broken strands during a scheduled inspection.

The stabilator "down" cable (P/N NAS 314-25-1411) was frayed with many broken strands at the forward pulley located just aft of the firewall and under the control column. (Refer to the following illustration.) The most likely cause of this defect was age and a high number of cycles. This area deserves close attention during scheduled inspections and maintenance.

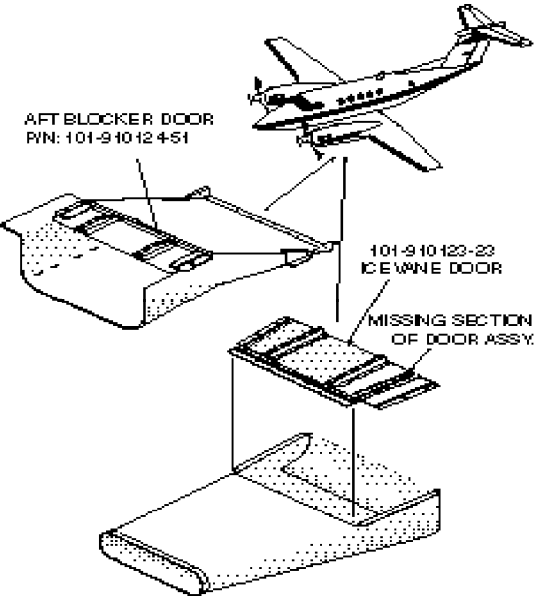
Beech Model 300 King Air	Cowling Ice Vane Door Broken 3080
---	--

A section of the left cowling ice vane door was found missing during a scheduled inspection.

The missing section of the door (P/N 101-910123-23) was approximately 4- by 8-inches. (Refer to the following illustration.) A foreign object damage (FOD) inspection of the engines first stage compressor revealed one blade edge was bent and torn. Due to this damage, the engine was removed for further inspection and repair.

An inspection of the right engine cowling ice vane door disclosed it was severely cracked in

the same location as the missing section of the left door. Also, the “ice vane aft blocker door” (P/N 101-910124-51) was found cracked on both the left and right cowlings.

The submitter recommended the manufacturer make the “bond assembly” thicker where the actuator brackets are attached.

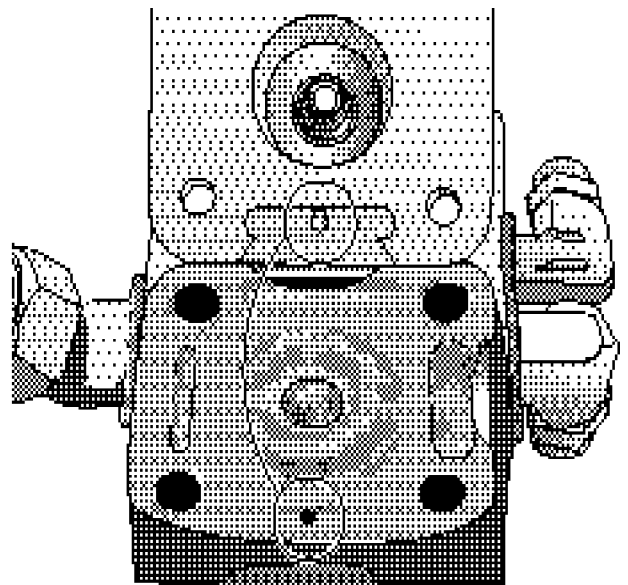
**Improper Fuel
Injection Pump
Operation**

All attempts at fuel pressure adjustment proved futile, and when the unmetered fuel pump pressure was increased, the engine operated in an "excessively rich" condition. After 100 hours of operation and troubleshooting, the fuel injector pump (P/N 642650-1) was removed and sent to a shop for a bench test and inspection. Only minor discrepancies were found, and the pump was returned as "serviceable." The fuel injector pump was reinstalled, and the operational flight test disclosed the problem had not been solved. After another 50 hours of operation and troubleshooting this problem, the fuel

injection pump was again removed and sent to a different shop for analysis. The new shop found the fuel pump cover (P/N 643950) had been installed 180 degrees out of position. This caused upper deck pressure to the fuel pump aneroid to be blocked from the passage which pressurizes the air side of the relief valve (P/N 642644) diaphragm. (Refer to the following illustration.) At the same time, the passage in the pump cover allowed the air side of the diaphragm to be exposed only to atmospheric pressure. Decreasing the atmospheric pressure, as the aircraft ascended on the air side of the diaphragm, could not compensate for turbocharger boost and resulted in a "self-leaning" fuel mixture to the engine.

Although this problem was caused by the person assembling the fuel pump having his head in the "up-and-locked" position, some safeguard should be incorporated to make this assembly a bit more "Murphy Proof." (Our apologies to all the Murphys of the world. No offense intended.)

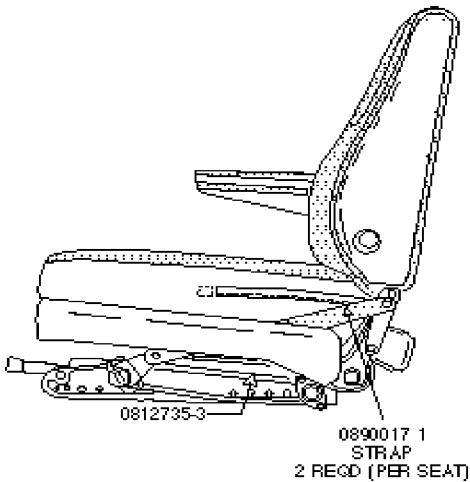
**Pilots Seat
Adjustment Fitting
Failure
2510**

A Cessna 310R aircraft crashed due to failure of the pilot’s seat adjustment fitting. (Refer to the following illustration.)

The manufacturer has issued Service Bulletin MEB 89-6, Revision 1, dated October 12, 1990, which adds metal straps to the pilot’s seat. These metal straps are intended to reduce the effects of “mechanical advantage” presented by abuse of the seat. The inspection procedures in (Number 25-10-00) the Cessna 300/400 series Continued Airworthiness Program specifically warn of the possible loss of aircraft control due to failure of the adjustment fittings (P/N’s 0812735-3 and -4). All operators of these aircraft are encouraged to comply with the instructions in Service Bulletin MEB 89-6 as soon as possible.

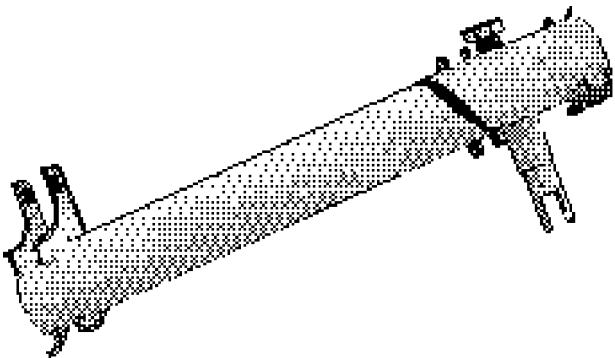
**Landing Gear
Torque Tube Failure
3230**

During an investigation, the left main landing gear torque tube (P/N 5045010-19) was cracked at the bolt boss on the fork. This crack had progressed in a spiral direction. (Refer to the following illustration.) The rod-end attachment to the torque tube was also damaged, and the damage was confirmed by a dye-penetrant inspection. Also, the right main landing gear was found cracked at the same location as confirmed by dye-penetrant inspection. When new parts were ordered from the manufacturer (Cessna Service Kit SK414-8E), the torque tube was noticed to incorporate a gusset at the fork bolt hole, and a larger diameter bolt was used. The submitter speculated this defect was caused by the high number of landing gear cycles and possibly extending the landing gear at too high an airspeed.

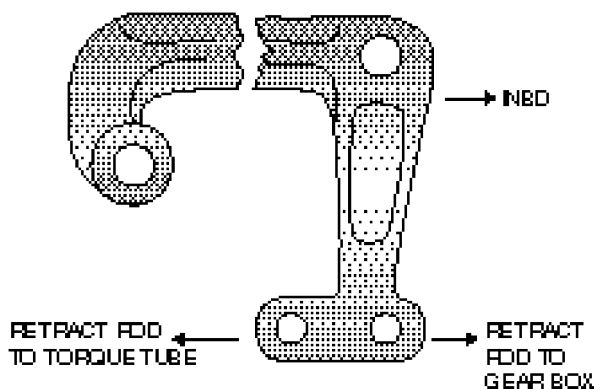
**Cessna
Model 310Q****Landing Gear Door
Failure
5280**

Just after takeoff, personnel in the control tower informed the pilot that the left main landing gear inboard door came open after the gear was retracted. A safe landing was made, and maintenance personnel were summoned.

The landing gear idler bellcrank (P/N 0841106-5) was found broken during an inspection. The bellcrank failed approximately 2 inches from the end of the arm which operates the gear door extend/retraction linkage. (Refer to the following illustration.) The failure point on the bellcrank revealed evidence of a previous crack which extended through approximately one-third of its thickness. It was suspected that improper landing gear rigging and excessive "door tension," with the gear down, contributed to and/or caused this failure.

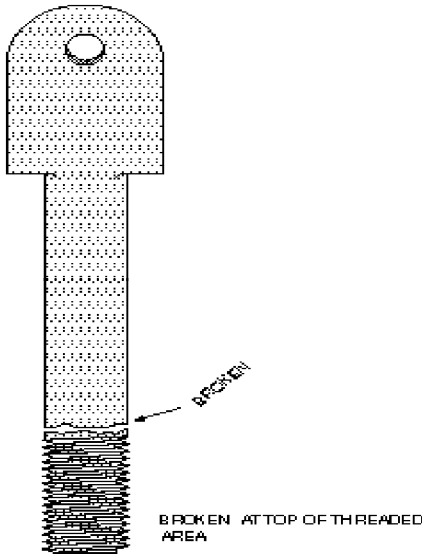
Cessna Model 402B Businessliner **Nose Landing Gear Damage 3230**

During a cross-country preflight inspection, the pilot discovered the nose landing gear fork bolt (P/N 5045211-2) was broken.

The fork bolt was broken at the junction of the threads and the shank. (Refer to the following illustration.) Also, the assembly began to pull away from the bellcrank (P/N 0842104-3). The location of this assembly makes inspection very difficult; however, it is worth the extra effort to avert a possible nose landing gear failure. Due to the excessively high number of operating hours, metal fatigue is the suspected cause of this defect.

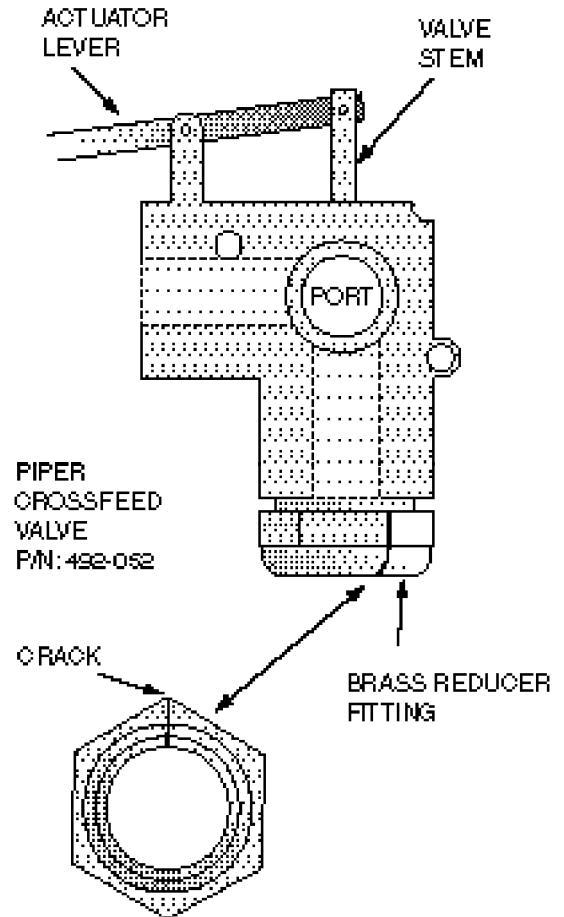
Piper **Fuel Crossfeed**
Model PA 23-250 **Valve Failure**
Aztec **2823**

An inspection of the fuel system disclosed the fuel crossfeed valve (P/N 492-052) brass reducer fitting was cracked. (Refer to the following illustration.) This fitting had not been disturbed for the past 6 years when it suddenly failed. With the fuel boost pump on, the crack sprayed and atomized fuel in a 2-inch fan pattern. The fuel then dripped down on the strobe light power supply creating a very hazardous condition. Since the brass fitting was no longer available from the manufacturer, it was necessary to replace the complete crossfeed valve.

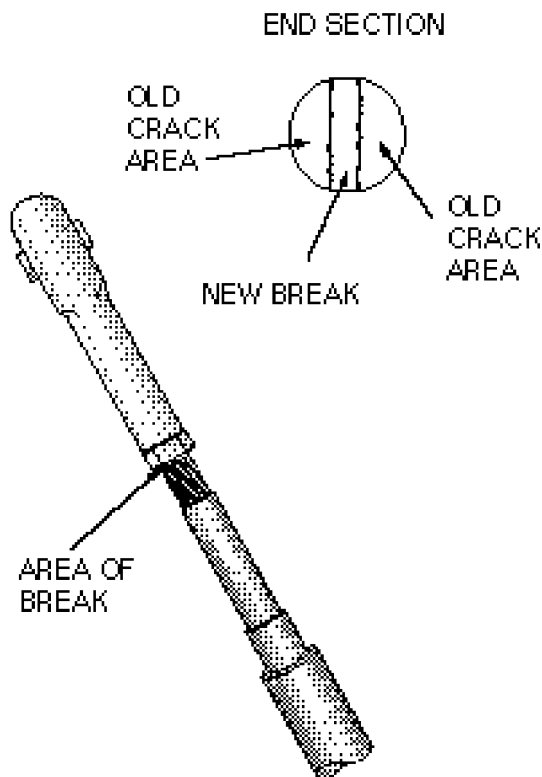
**Nose Landing Gear
Steering Shaft
Failure
3250**

The nose landing gear center shaft of the centering spring assembly (P/N 96522-00) was found sheared during a scheduled inspection.

The shaft failed at the rod-end attachment threaded area. (Refer to the following illustration.) A visual inspection of the broken shaft indicated it had been partially cracked in a vertical direction for some time prior to complete failure. It was suspected this damage was caused by exceeding the turning limits (while towing the aircraft). Frequent inspection of this area and adherence to the specified turning limits while towing were recommended.

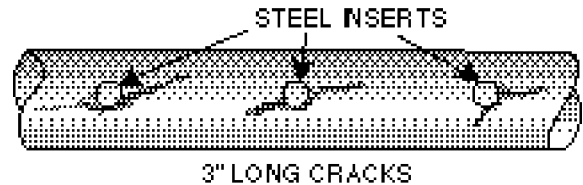
**Skid Tube Cracks
3270**

A skid tube was found cracked during a scheduled inspection. This finding prompted an inspection of the skid tube (P/N 206-324-003) on the opposite side, where severe corrosion damage was discovered. (No cracks were found on this skid tube.)

Both of the skid tubes had been installed 27 months prior to this discovery. The cracks appeared to originate at the steel inserts. (Refer to the following illustration.) It was speculated that improper installation or hole preparation for the inserts may have induced stress which caused the cracks. These skid

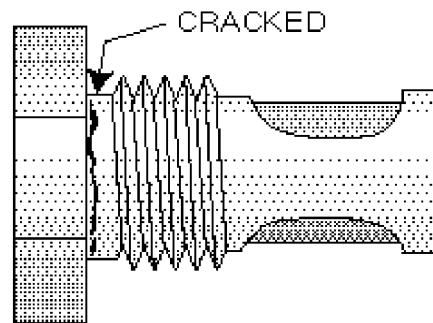
barrel. (Refer to the following illustration.) The crack traveled around the entire circumference; however, it had not penetrated the wall thickness of the plug barrel. The submitter did not offer a cause for this defect; however, it seems likely that excessive torque may have been a factor.

Defective Main Rotor Transmission Drain Plug 6330

The main rotor transmission drain plug was found cracked during overhaul.

The plug (P/N B3148A) was cracked in the radius at the junction of the head and the plug

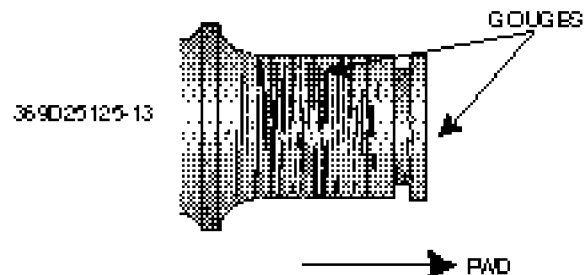
Tail Rotor Pinion Shaft Damage 6400

The main rotor transmission and the tail rotor output pinion shaft were found damaged during an overhaul and inspection.

It was determined the damage had been caused by a broken bearing race. The output pinion shaft (P/N 369025125-13) was severely gouged at the bearing land and retaining ring lip. (Refer to the following illustration.) The shaft was replaced due to gouges and nicks. This area should be closely checked at every opportunity.

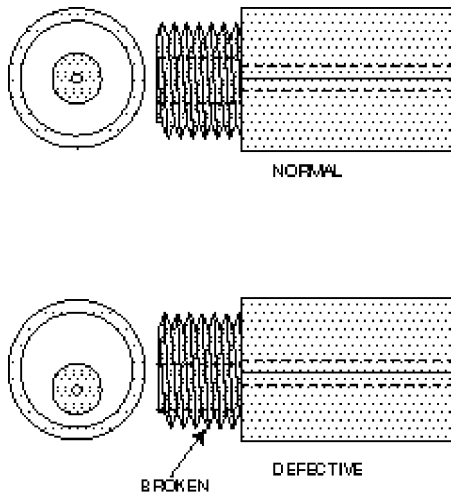
it was being removed. Further inspection revealed the orifice in the outlet end of the injector was drilled "off center." (Refer to the following illustration.) Failure to have an injector in this area would allow raw fuel to be expelled and present a potentially hazardous condition. The submitter suggested that injectors be closely inspected for this condition at every opportunity.

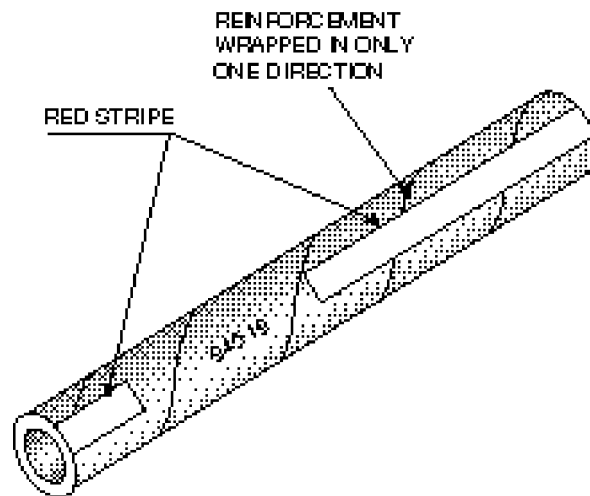
DEFECTIVE AVIATION HOSES

manufactured by Buckeye Rubber Products, Inc., is of a spiral wrapped construction with a .375-inch wide red stripe and the number 94519 may be visible. (Refer to the following illustration.) Defective hoses have been found with the following quarterly manufacturing date markings: 2Q94, 1Q95, 2Q95, and 3Q95. Also, hoses with other manufacturing date markings may be suspect.

All maintenance technicians should be alert for the presence of these hoses, either installed on an aircraft or new from a parts distributor.
